## Monitoring Report No. 61

Duncrun  
Co. Derry

AE/06/88

## Site Specific Information

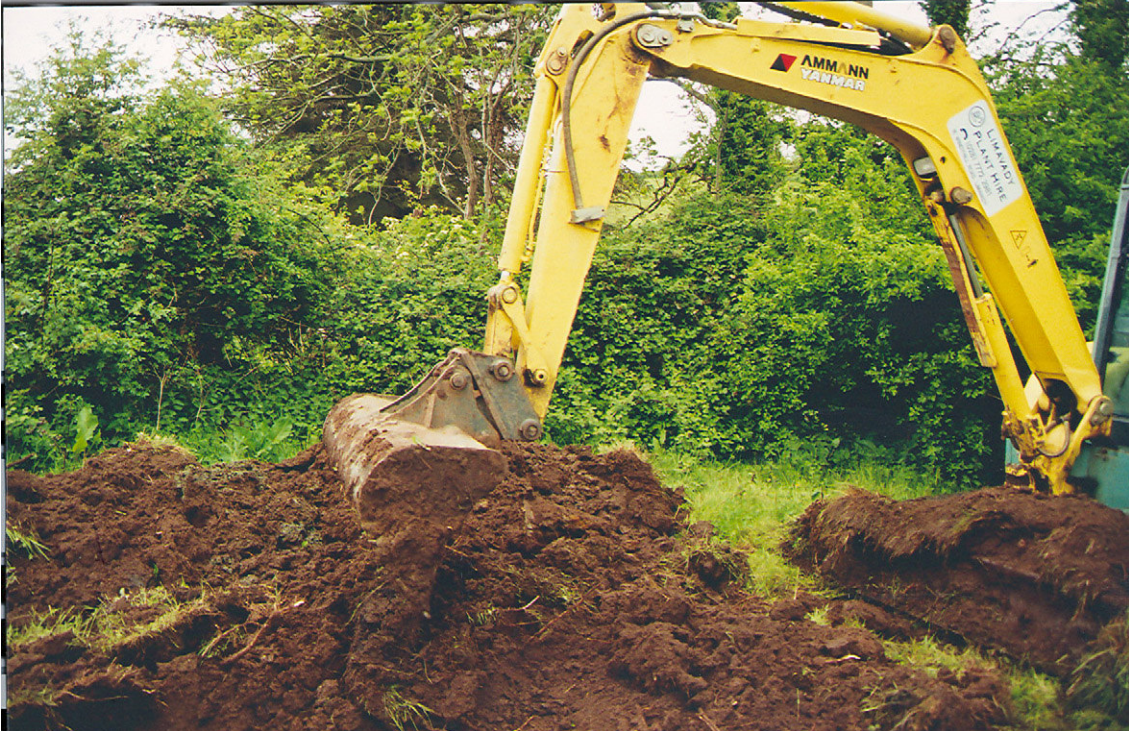
*Photo 1: Excavation of Trench 1 showing utilization of toothless “sheugh” bucket.*

A total of four trenches were excavated as part of the evaluation procedure (Figure 3). The trenches were excavated using a mechanical digger equipped with a toothless “sheugh” bucket (Photo 1). Trench 1 measured 3m by 28m, Trench 2 measured 5m by 28m, Trench 3 measured 5m by 28m and Trench 4 measured 2.5m by 28m. The areas in between the trenches were used for the placement of excavated topsoil. There was an area in the centre of the site which was left unexcavated because of the presence of a drain.

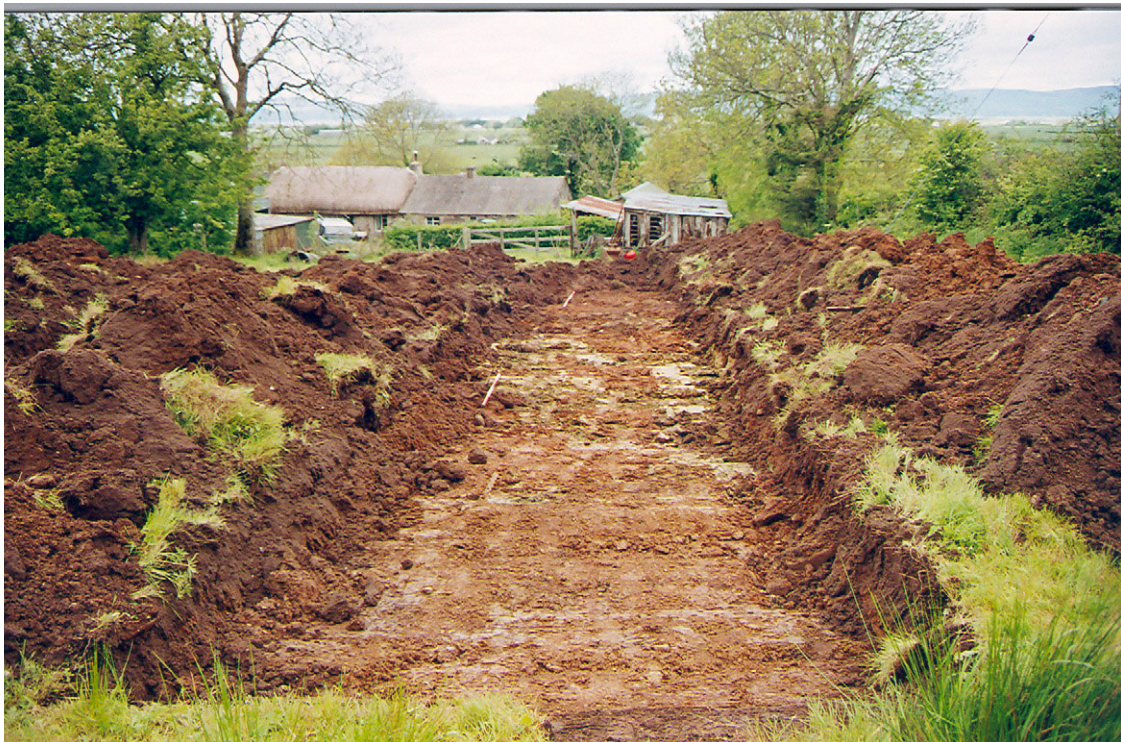
**Trench 1:** This trench was 3m wide by 28m long. It ran northwest-southeast and was located 4m from the northeastern boundary and 5m from the southeastern boundary of the field. The topsoil was a reddish brown loam (Context 101), which was up to 50cm in depth. The topsoil sat directly on the subsoil (Context 102). The subsoil consisted of reddish orange sandy clay. No archaeological artifacts or features were found during the excavation of this trench (Photo 2).

*Photo 2: Trench 1 looking northwest after excavation showing surface of subsoil (Context 102).*

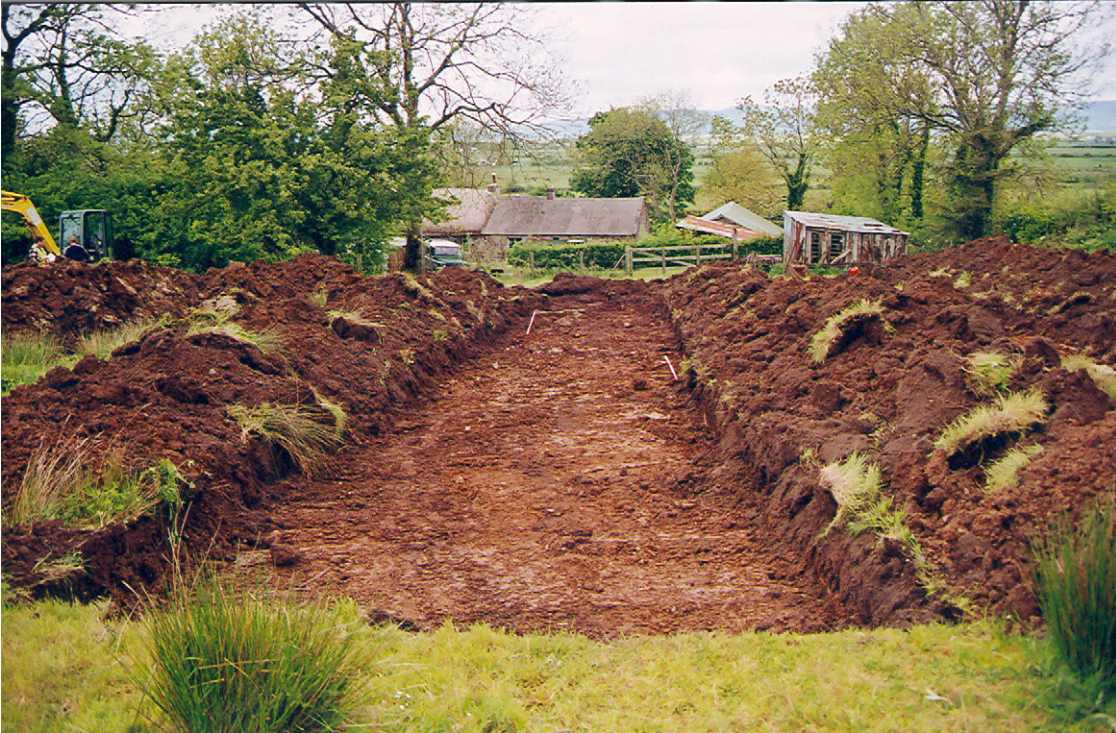
**Trench 2:** This trench was 5m wide by 28m long. It ran northwest-southeast and was located parallel to, and 2m southwest of, Trench 1. The topsoil in this trench was a reddish brown loam (Context 201), which was up to 50cm in depth. The topsoil sat directly over the reddish orange, sandy clay subsoil (Context 202). No archaeological artifacts or features were found during the excavation of this trench (Photo 3).

*Photo 3: Trench 2 looking northwest after excavation showing surface of subsoil (Context 202).*

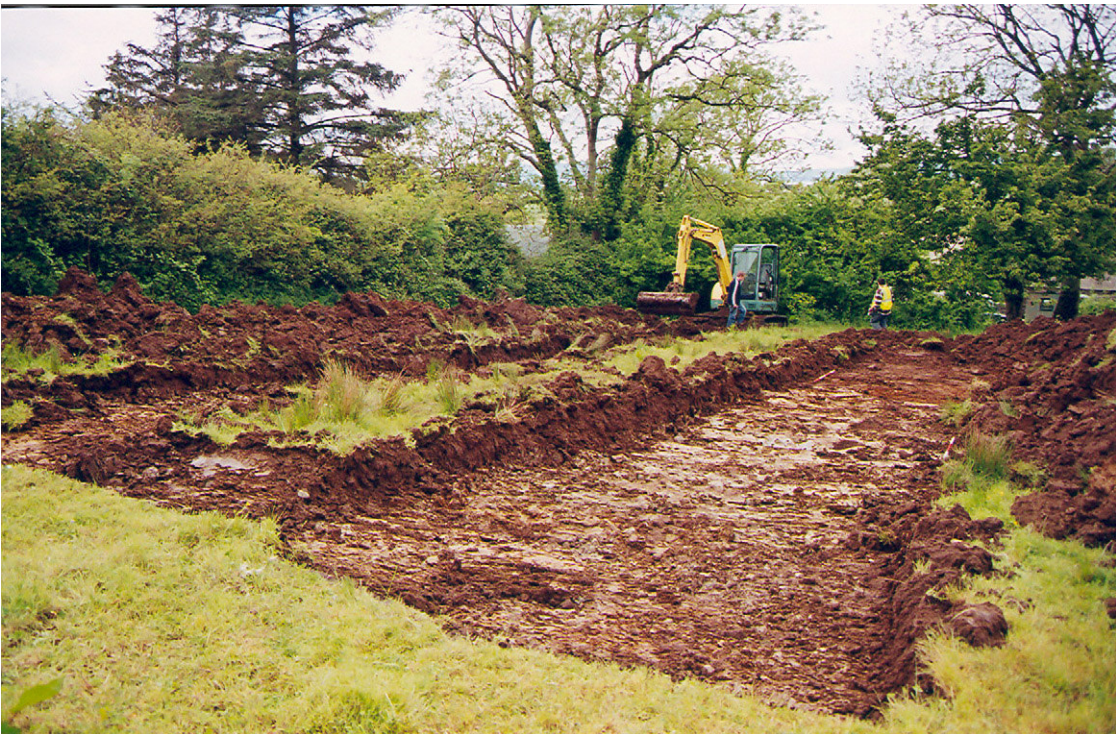
**Trench 3:** This trench was 5m wide by 28m long. It ran northwest-southeast and was located parallel to, and 7m southwest of, Trench 2. There was a large gap between Trenches 2 and 3 to protect a covered drain and to facilitate the placement of spoil. The topsoil in this trench was a reddish brown stoney loam (Context 301), which was up to 30cm in depth. The topsoil sat directly over the reddish orange, sandy clay subsoil (Context 302). No archaeological artifacts or features were found during the excavation of this trench (Photo 4).

*Photo 4: Trench 3 looking northwest after excavation showing surface of subsoil (Context 302).*

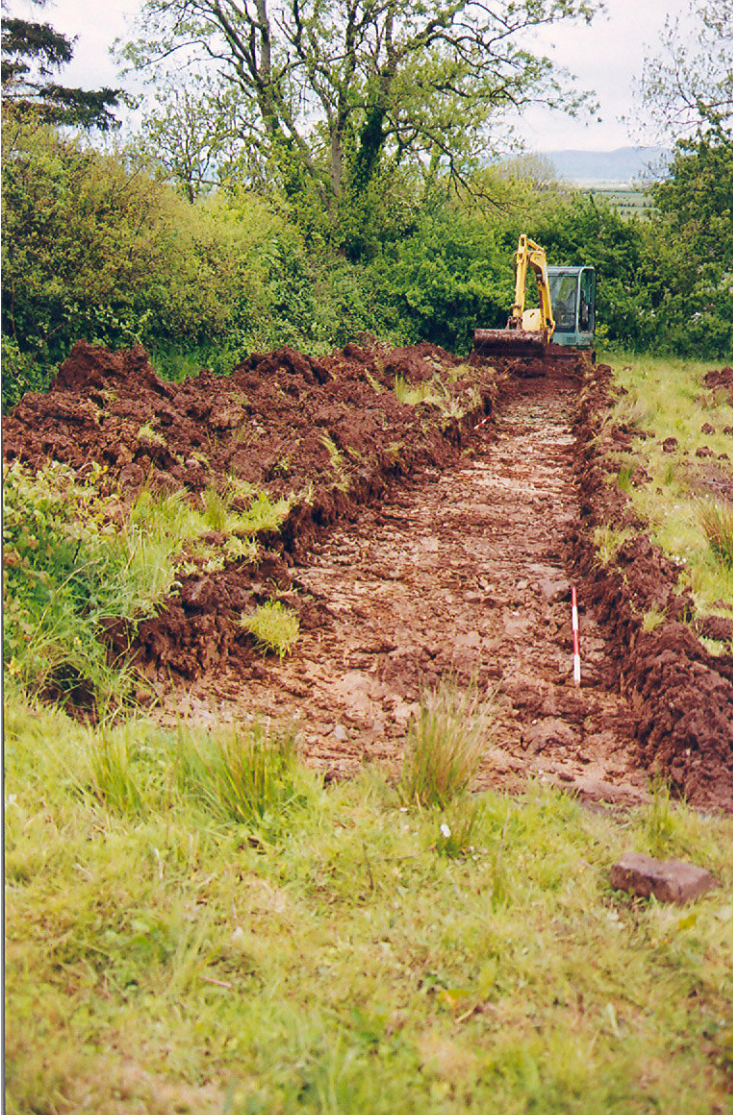
**Trench 4:** This trench was 2m wide by 28m long. It ran northwest-southeast and was located parallel to, and 2m southwest of, Trench 3. The topsoil in this trench was a reddish brown stoney loam (Context 401), which was up to 30cm in depth. The topsoil sat directly over a greenish grey clay subsoil (Context 402). No archaeological artifacts or features were found during the excavation of this trench (Photo 5).

*Photo 5: Trench 4 looking northwest after excavation showing surface of subsoil (Context 402).*
