**Monitoring Report No. 204**

**Dunmull Hillfort  
South of 18 Ballyhome Road  
Coleraine  
Co. Antrim**

C/2007/0728/RM

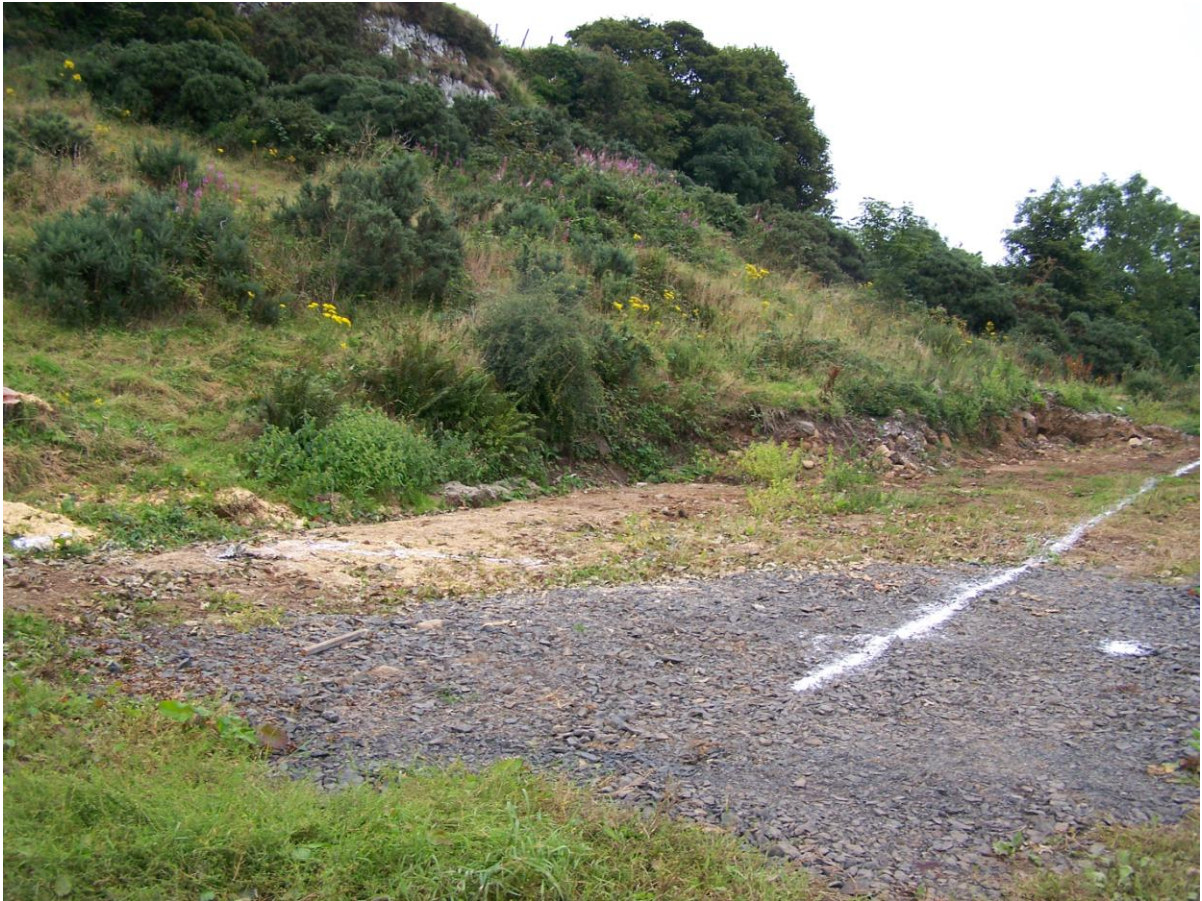
Plate 1: Proposed development site following McAleenan's evaluation and prior to the the monitoring exercise taking place, looking north-east.

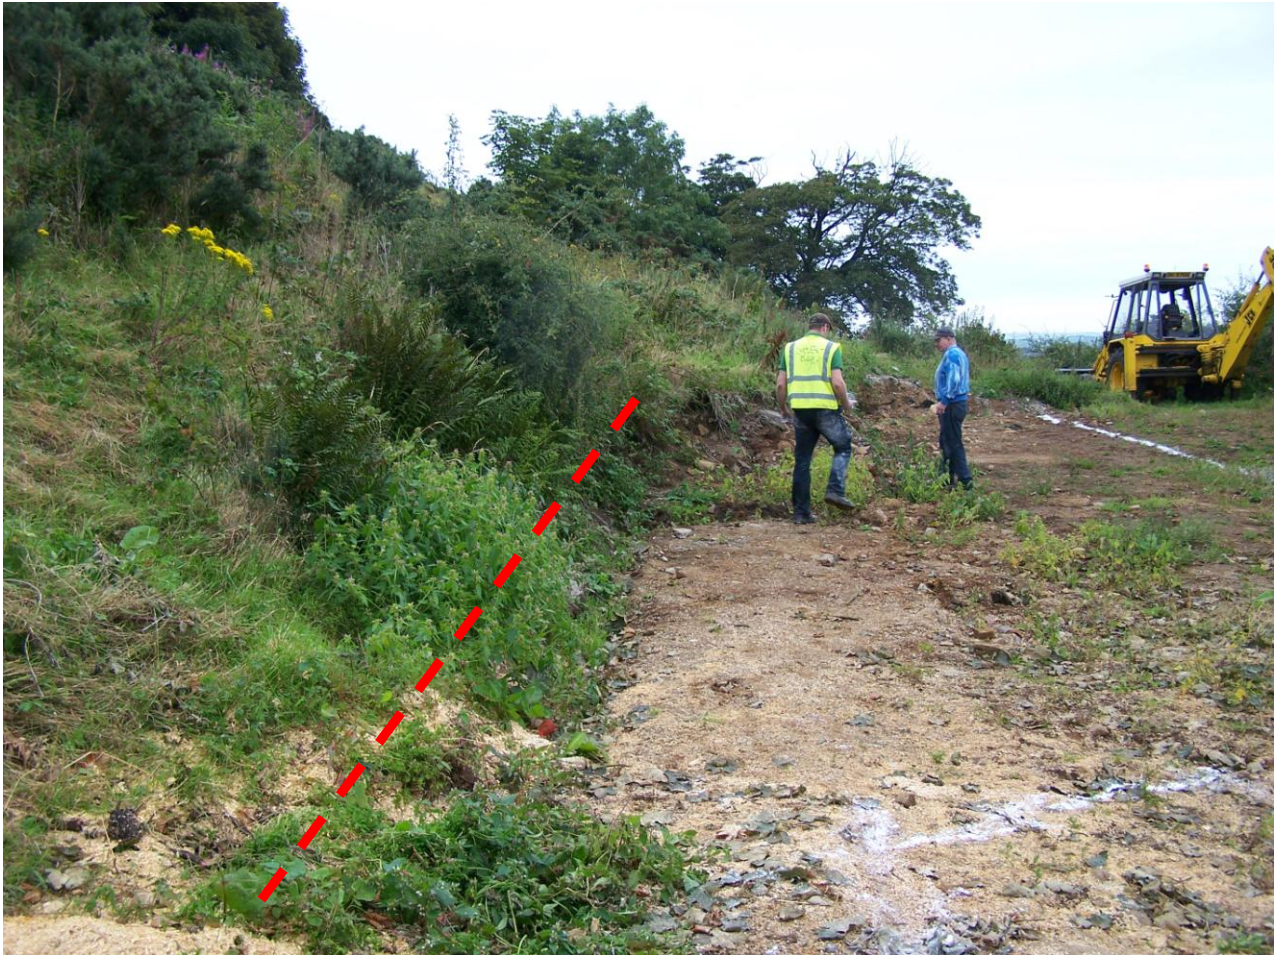
Plate 2: Approximate edge of the scheduled area (red dashed line). This was located due to the remains of the back wall of the now demolished building, looking east.

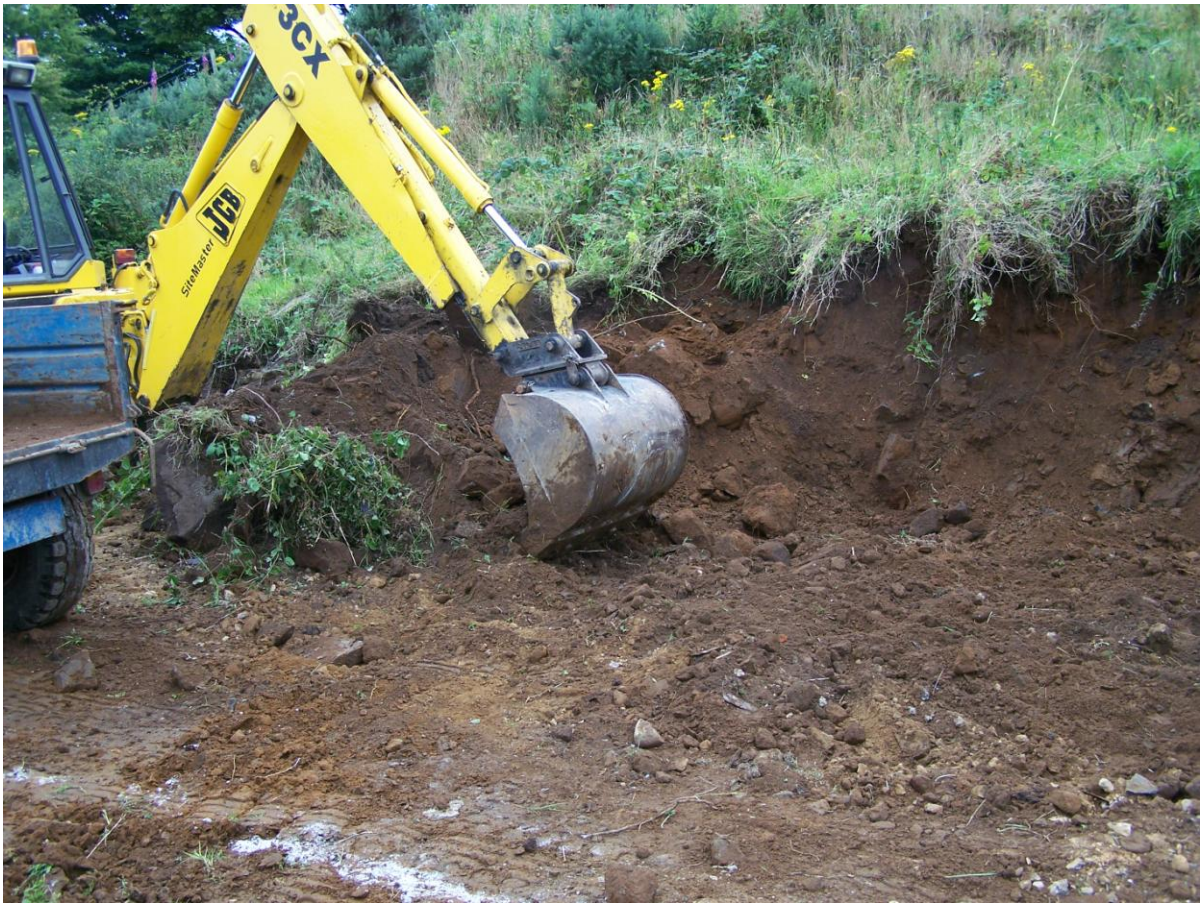
Plate 3: Mechanical excavation 0.5m into scheduled area, looking north.

A mechanical excavator was utilised to remove the spoil from a service trench at the rear of the proposed replacement dwelling. This trench measured roughly 32m in length, 1.5m in width, and was excavated into the natural bedrock. Approximately 0.5m of the width of this trench encroached upon the scheduled area. A simple stratigraphic sequence was encountered during the monitoring exercise, with sod and topsoil directly overlying natural subsoil/bedrock. Several large angular boulders were encountered, and it is postulated that these originated at the rocky outcrop situated above the proposed

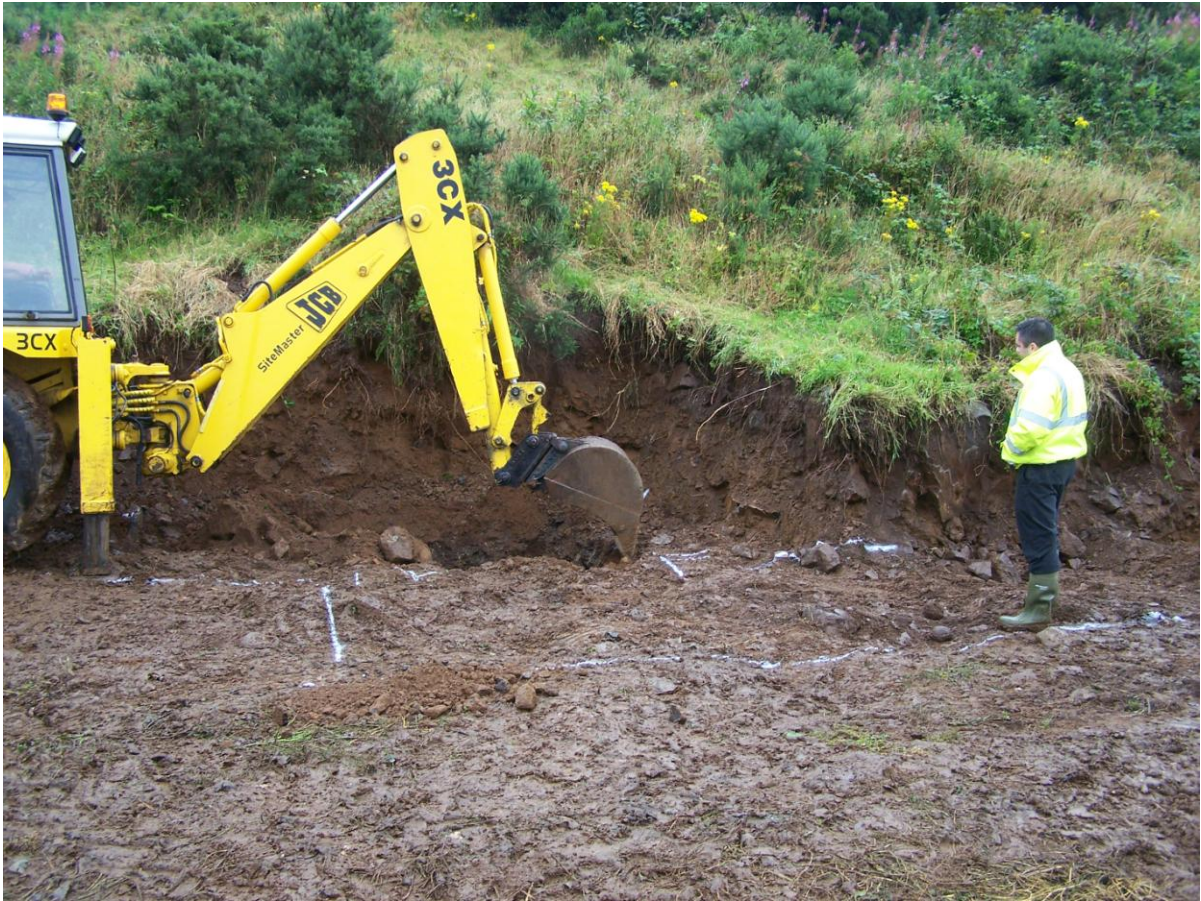
Plate 4: Excavation of the service trench, looking north.

development site. The average depth of the topsoil and upper strata was 0.4m. Nothing of archaeological significance was encountered during this monitoring exercise and no further investigation is deemed necessary.
