Evaluation/Monitoring Report No. 247

**176 CAUSEWAY ROAD
FEIGH ALIAS DUNSEVERICK
BUSHMILLS
COUNTY ANTRIM**

LICENCE NO.: AE/12/121E

Brief Summary:

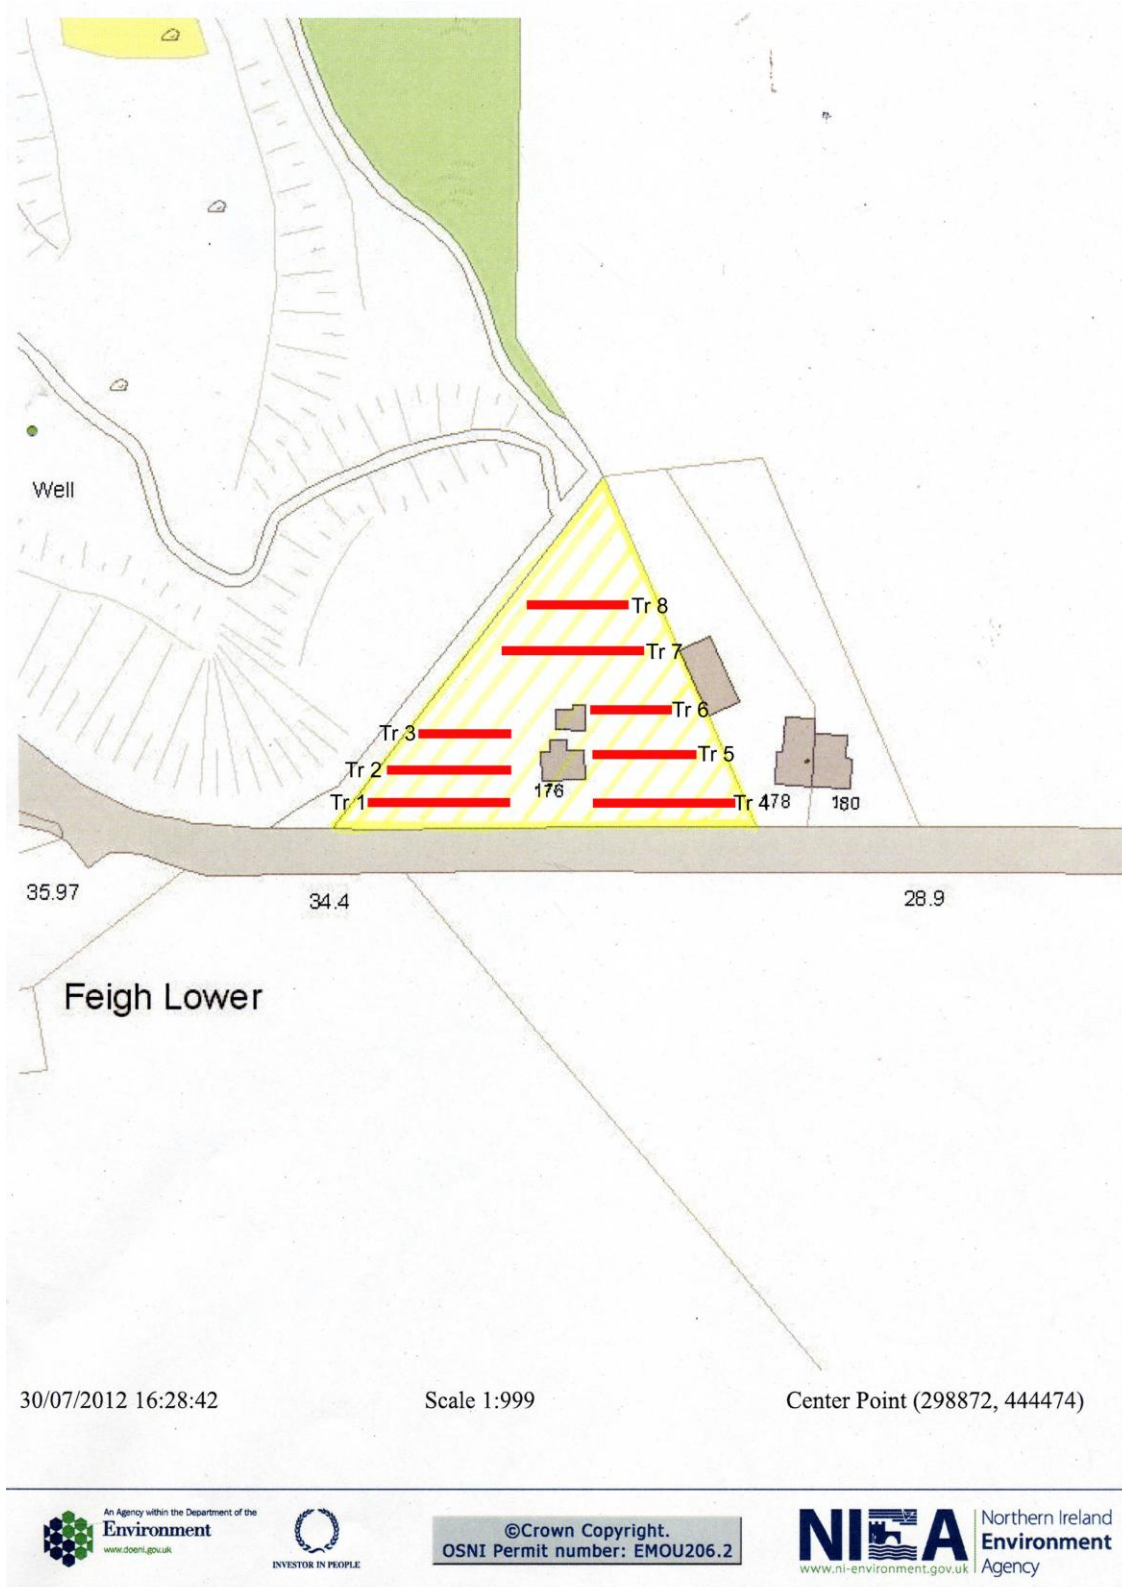
Figure 3: Site plan showing location of test trenches

The evaluation request allowed for the excavation of trial trenches, the proposed location of which was indicated in the original research design. A total of eight test trenches were excavated in the application area (Figure 3). These differed from the original research design due to the presence of the house and outbuildings on the site.

The trenches were 1.3-1.5m wide and 10.0-20.0m long. Each was excavated to the surface of the natural subsoil which was encountered at an average depth of 0.3m.

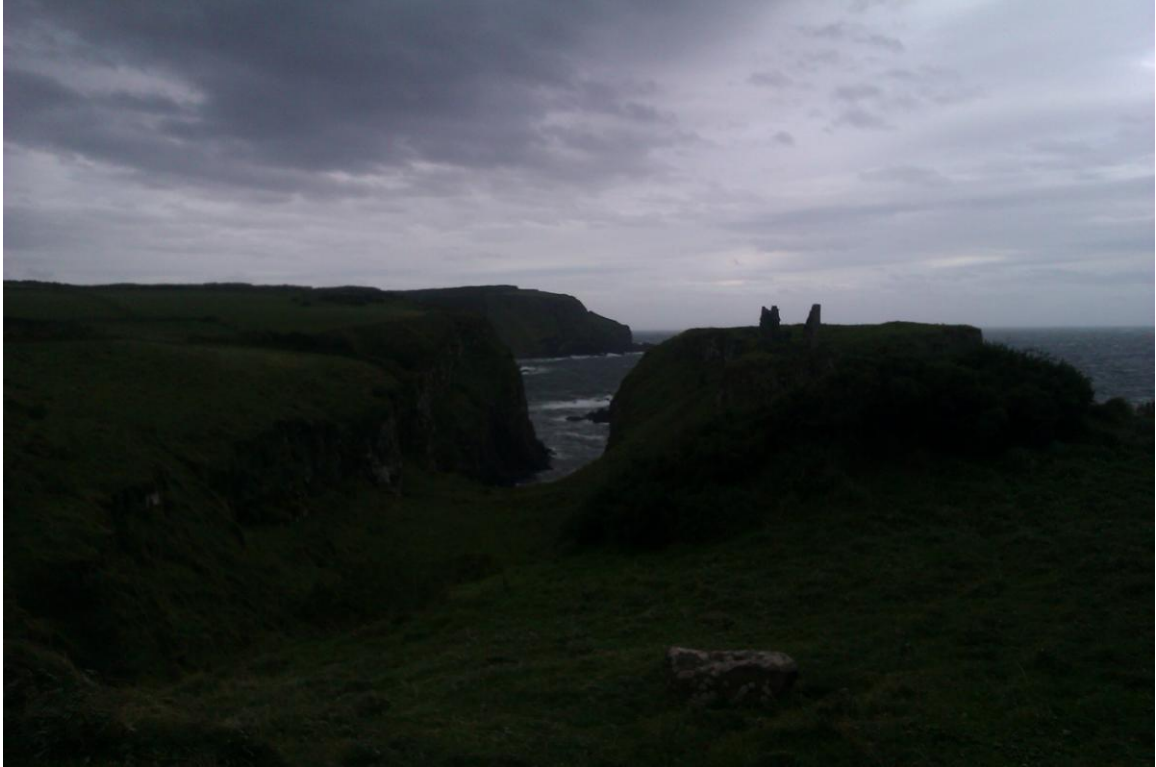
Plate 1: Dunseverick Castle (ANT 003:011), looking north-west

The application site for a replacement dwelling and detached garage is located 5km north-east of Bushmills, along the Antrim coast road (Figure 1). The site is approximately 150m to the south-east of Dunseverick Castle (NISMR ANT 003:011) which occupies the top of a steep-sided rocky promontory (Figure 2 and Plate 1). A holy well (St Patrick's well: NISMR ANT 003:035) was also recorded close to the castle in the Northern Ireland Sites and Monuments Record (NISMR). A roughly oval depression towards the north-western end of the promontory on which the castle was built may represent the remains of the well.

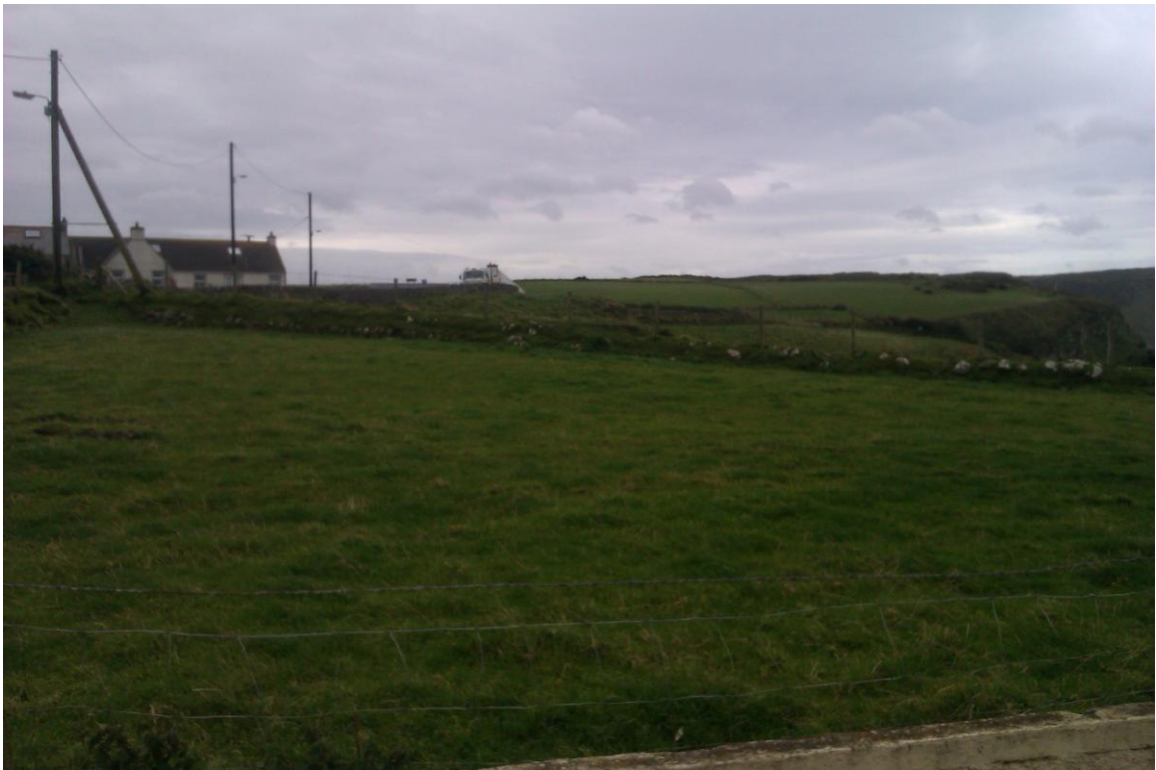
Plate 2: General view of site prior to evaluation, looking west

The application site consists of a triangular field approximately 0.21 hectares in size (Plate 2). It is bounded to the south by the Causeway Road and on the north-western and north-eastern sides by post-and-wire fences beyond which is heathland leading to the coast (Plates 3 and 4). A house and outbuildings occupy the centre of the site, close to the road. The remainder of the land surrounding the house is grass, occasionally used for grazing. There are good views in all directions, including to Rathlin Island to the north-east. The site is quite exposed and on the day of the evaluation there was a strong north-easterly wind.

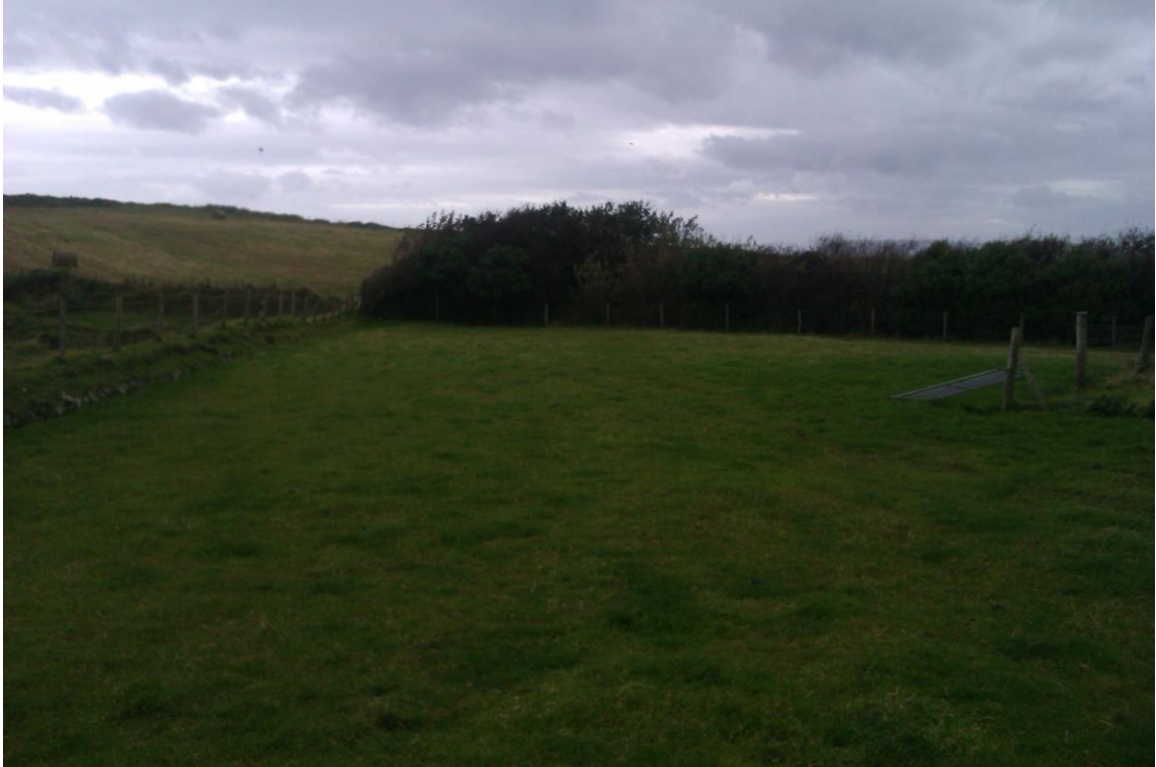
Plate 3: General view of site prior to evaluation, looking north north-east

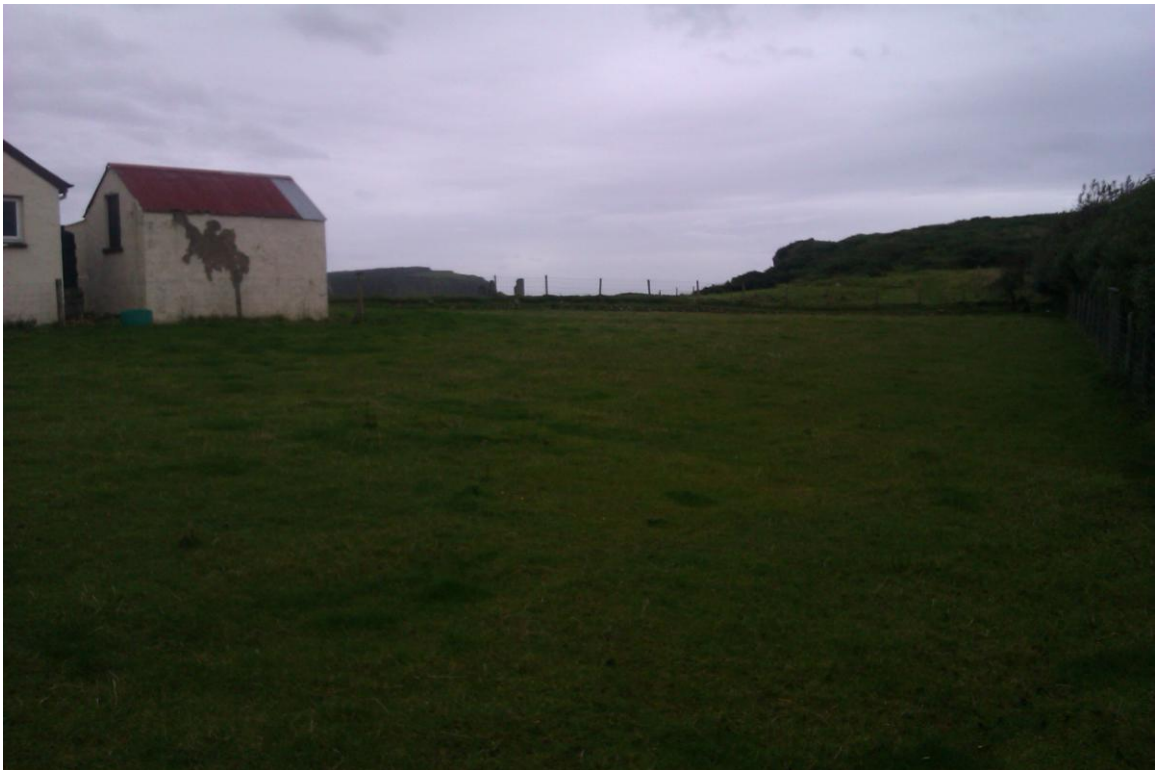
Plate 4: General view of site prior to evaluation, looking north-west

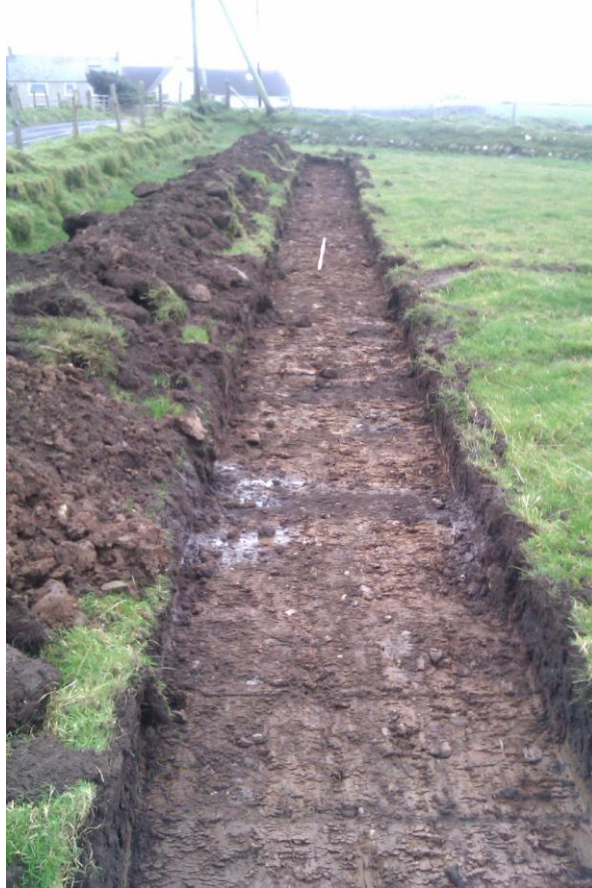
Trench 1 was 1.5m wide and 20.0m long (Plates 5 and 6). It was located on the western side of the house and 2.0m to the north of the road/southernmost field boundary to which it ran parallel. The uppermost layer in Trench 1 was the sod and topsoil layer (C101) which consisted of dark brown humic loamy clay. The layer was 0.14m thick. Below the sod and topsoil layer was a cultivation soil (C102) consisting of sandy clay which was brownish black in colour and 0.18m thick. It contained some small sub-rounded and sub-angular stones up to 10mm long. The cultivation layer also contained a few sherds of 19th century pottery and some naturally occurring flint. Below the cultivation layer was the subsoil (C103) which consisted of orange boulder clay, the surface of which was encountered at a depth of 0.30-0.32m. There were patches of burning and superficial traces of cultivation furrows in the subsoil but nothing of archaeological significance was noted.

Plate 5: Trench 1 following removal of upper deposits, looking west

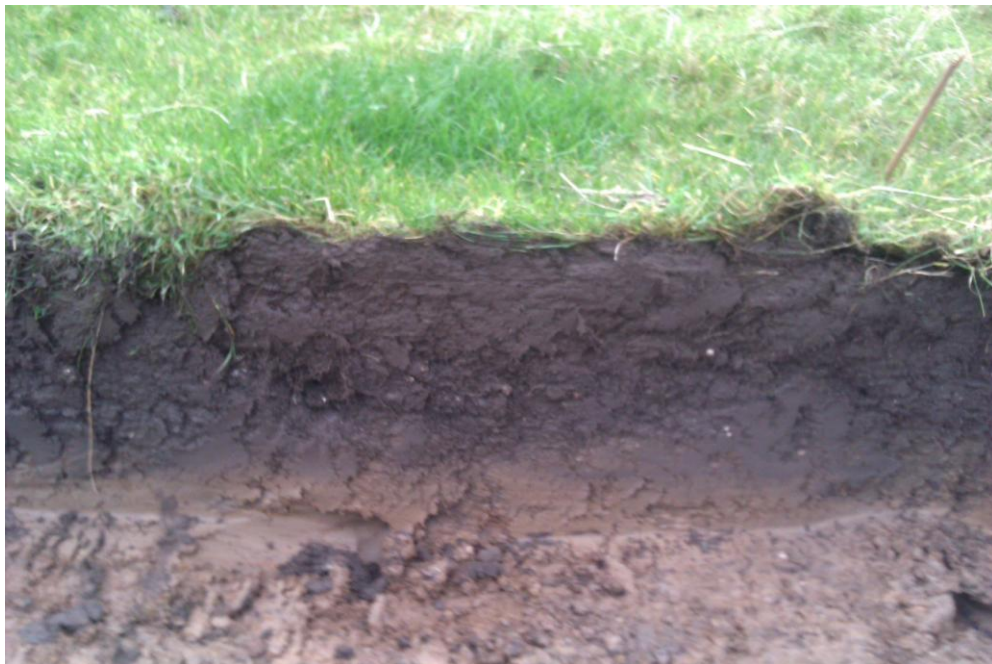
Plate 6: South-facing section of Trench 1, looking north

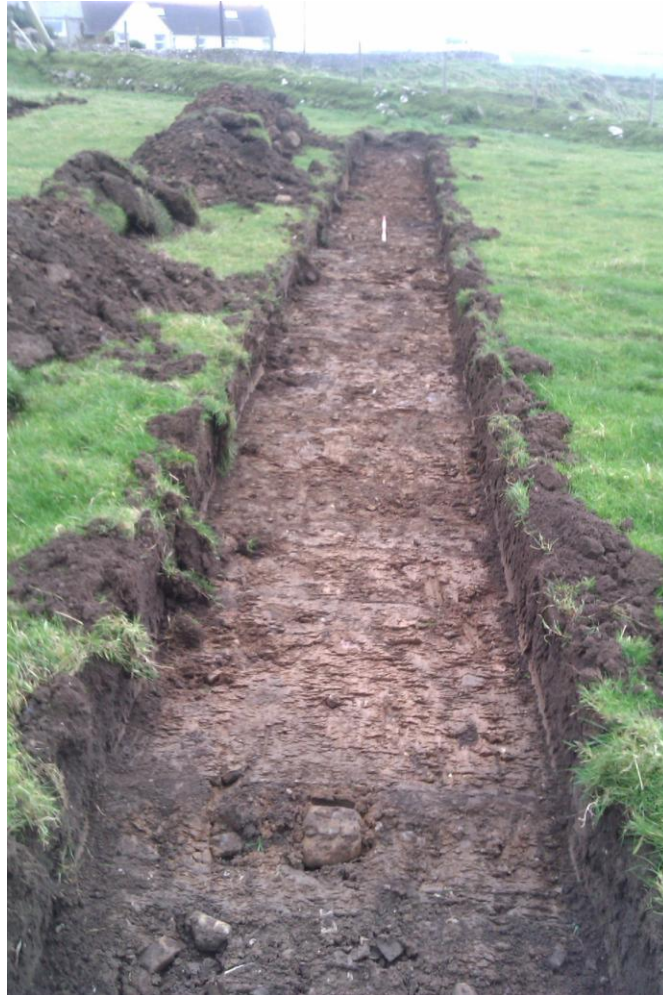
Trench 2 ran parallel to Trench 1 and was located 5.0m to the north of it. The trench was 1.4m wide and 17.0m long (Plates 7 and 8). The sod and topsoil layer in Trench 2 (C201) consisted of humic, loamy clay with a spongy consistence and few inclusions. The layer was dark brown in colour and 0.13m thick. Below the sod and topsoil layer was a cultivation soil of brownish black sandy clay (C202) which was up to 0.20m thick. The cultivation soil contained sub-rounded stones of up to 30mm in length as well as a few sherds of 19th and 20th century pottery. The cultivation layer directly overlay the orange boulder clay subsoil (C203), the surface of which was encountered at a depth of 0.33m. There were no finds or features of archaeological significance uncovered in Trench 2.

Plate 7: Trench 2 following removal of upper deposits, looking west

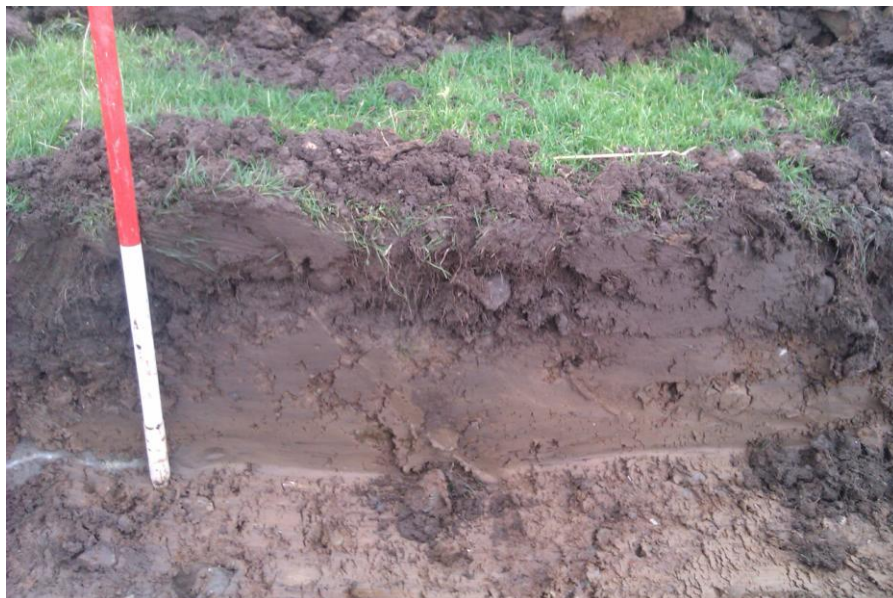
Plate 8: North-facing section of Trench 2, looking south

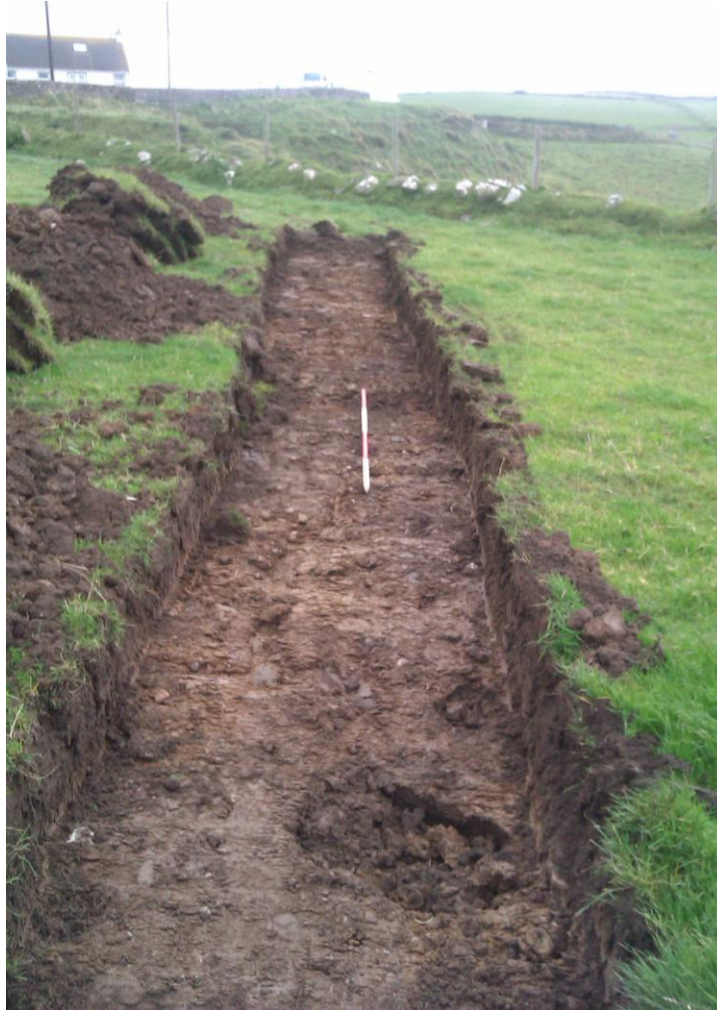
Trench 3 was located 5.0m to the north of Trench 2 and ran parallel to it. The trench was 1.5m wide and 11.0m long (Plates 9 and 10). The uppermost deposit in Trench 3 was the sod and topsoil layer (C301) which consisted of dark brownish black humic loamy clay which was 0.12m thick. It overlay a cultivation soil (C302) of dark brownish black sandy clay which contained sub-rounded stones up to 30mm long as well as some sherds of 19th and 20th century pottery. The layer was 0.20m thick. Below the cultivation layer, at the western end of the trench, was a gravelly layer (C303) which overlay the natural subsoil. The gravelly layer consisted of poorly sorted angular and sub-angular stones between 50mm and 200mm long. It appeared to be the remains of the gravel pathway. The subsoil in Trench 3 (C304) consisted of orange boulder clay which contained decaying stones. The surface was encountered at a depth of 0.32m. There were no finds or features of archaeological significance within the subsoil.

Plate 9: Trench 3 following removal of upper deposits, looking west

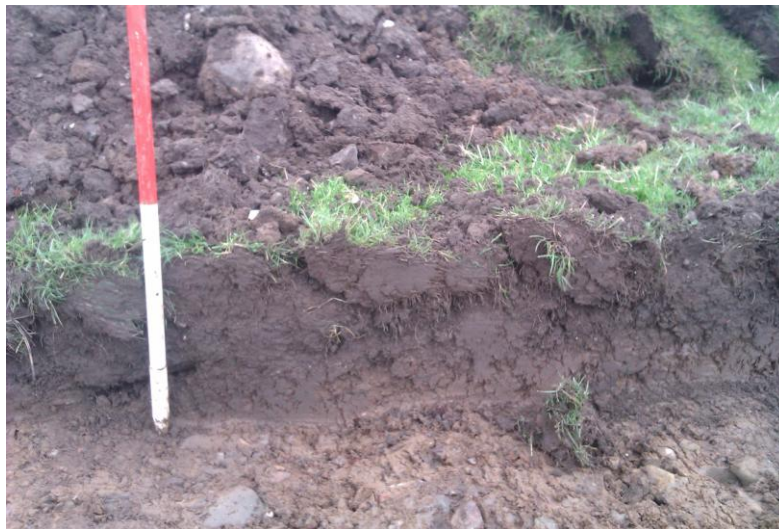
Plate 10: North-facing section of Trench 3, looking south

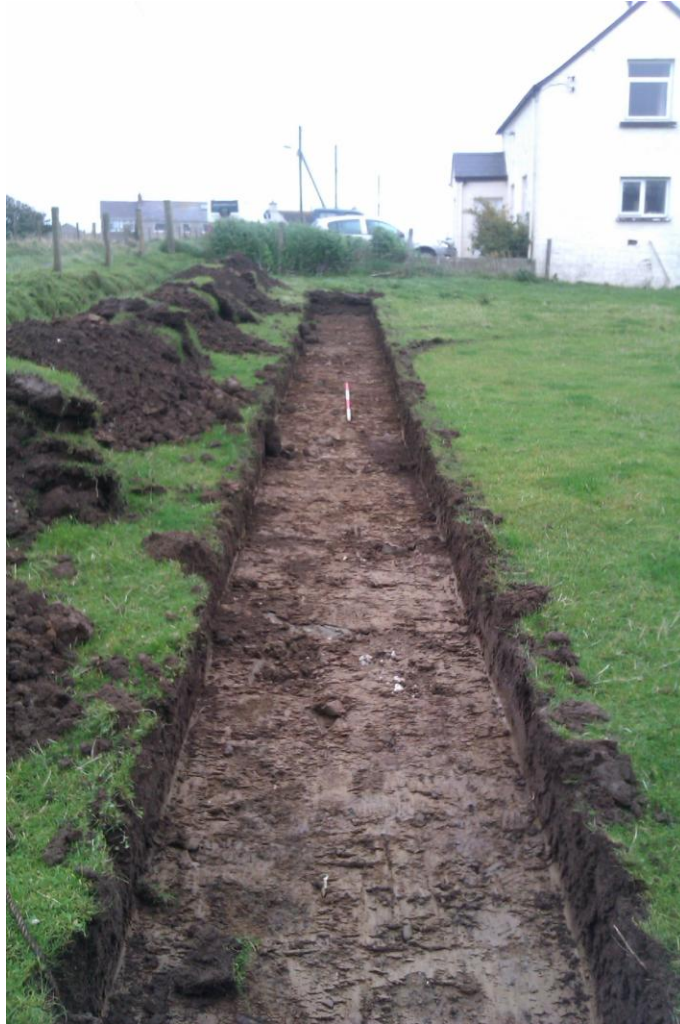
Trench 4 was located on the eastern side of the house, parallel to the southernmost field boundary and 3.0m to the north of it. The trench was 1.3m wide and 20.0m long (Plates 11 and 12). The sod and topsoil layer in Trench 4 (C401) consisted of dark greyish brown humic loamy clay which was up to 0.10m thick. Below the sod and topsoil layer was a cultivation layer (C402) comprised of loamy clay which was dark brown in colour and compact. The layer was up to 0.24m thick and contained infrequent stone inclusions as well as several sherds of 19th century pottery. Below the cultivation layer was the subsoil (C403) which consisted of orange boulder clay which was sandier and less stony than the subsoil recorded in Trenches 1-3. There was struck flint pressed into the surface of the subsoil but no evidence of archaeological features. The surface of the subsoil was encountered at a depth of up to 0.34m.

Plate 11: Trench 4 following removal of upper deposits, looking west

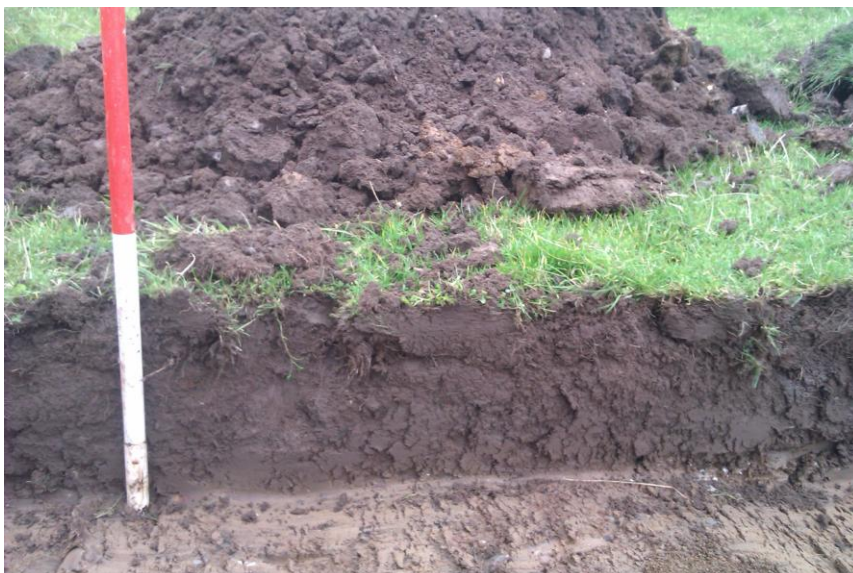
Plate 12: North-facing section of Trench 4, looking south

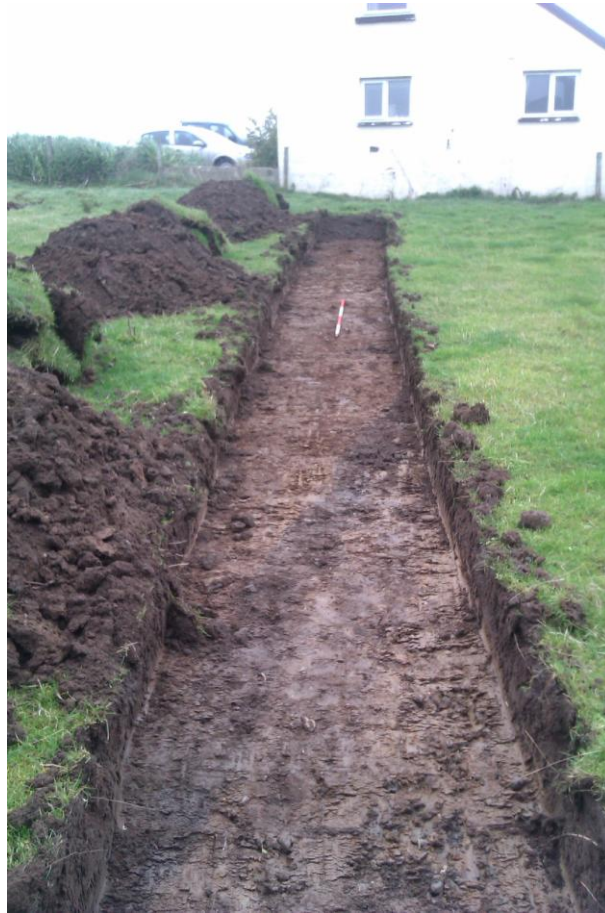
Trench 5 was located 8.0m to the north of Trench 4 and ran parallel to it. The trench was 1.5m wide and 15.0m long (Plates 13 and 14). The sod and topsoil layer in Trench 5 (C501) consisted of greyish brown humic loamy clay which was up to 0.12m thick. It overlay a cultivation soil consisting of dark greyish brown loamy clay (C502).

Plate 13: Trench 5 following removal of upper deposits, looking west

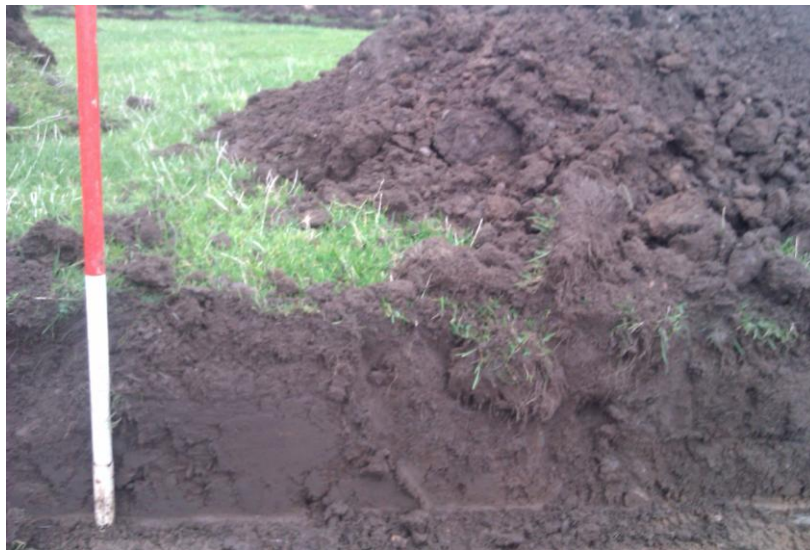
The cultivation soil was compact and up to 0.20m thick. It contained sub-angular stone inclusions around 40mm long as well as 19th century pottery. Following the removal of the cultivation soil a linear feature was visible running north-west/south-east across the trench (Plate 15). The cut (C503) of the feature was up to 0.30m wide and the fill (C504) consisted of greyish brown silty clay loam. The feature ran towards a manhole cover beside the house and resembled a modern pipe trench. Stratigraphically below the linear feature was the natural subsoil (C505) which consisted of orange boulder clay. There were no features of archaeological significance but several pieces of struck flint were pressed into the surface of the subsoil. The subsoil was encountered at a depth of 0.32m.

Plate 14: North-facing section of Trench 5, looking south

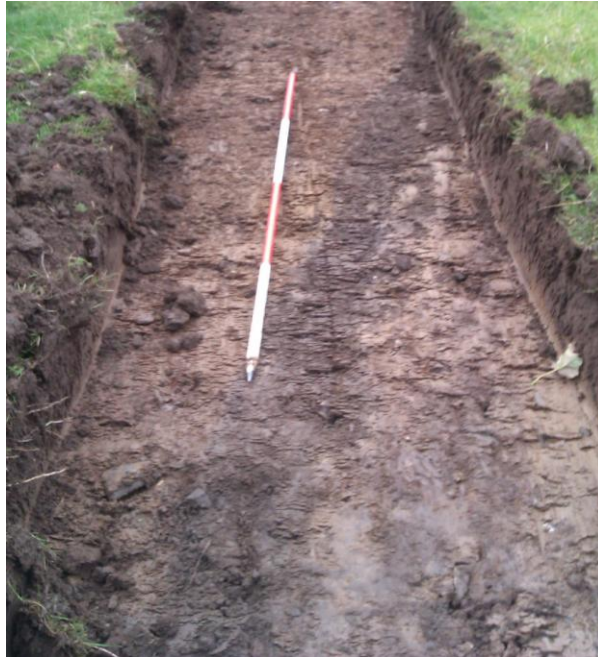
Plate 15: Pipe trench in Trench 5 (C503/504), looking west

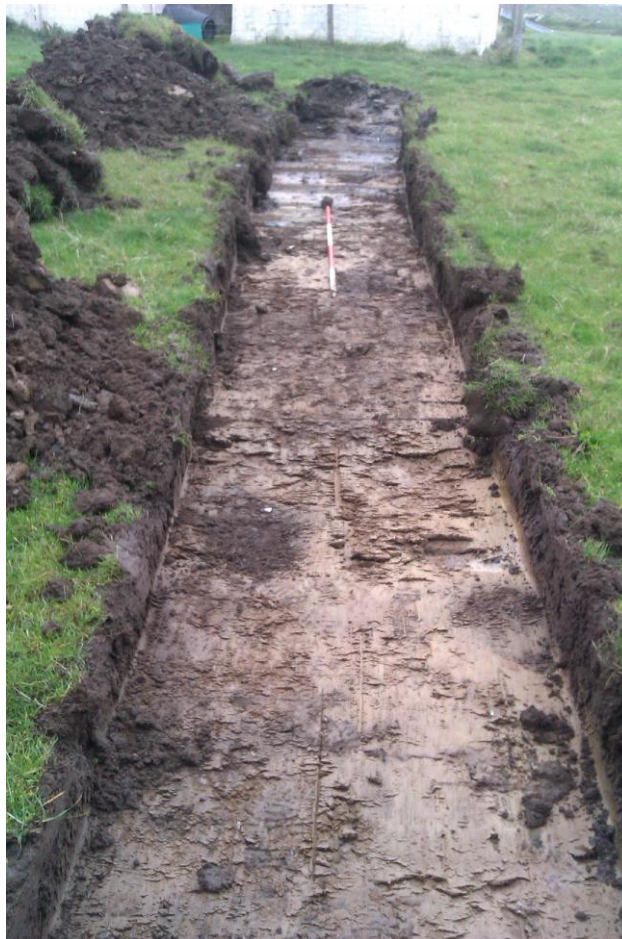
Trench 6 was located 6.0m to the north of Trench 5 and ran parallel to it. The trench was 1.3m wide and 10.0m long (Plates 16 and 17). The sod and topsoil layer in Trench 6 (C601) consisted of dark brown humic loamy clay which was 0.13m thick. Below this was a cultivation soil (C602) of dark brown loamy clay up to 0.14m thick. This layer contained 19th and 20th century pottery as well as a few pieces of struck flint. Below the cultivation soil was the subsoil (C603) consisting of pale orange sandy boulder clay which was water-logged in places. The surface of the subsoil was encountered at a depth of 0.27m. There were no finds or features of archaeological significance in Trench 6.

Plate 16: Trench 6 following removal of upper deposits, looking west

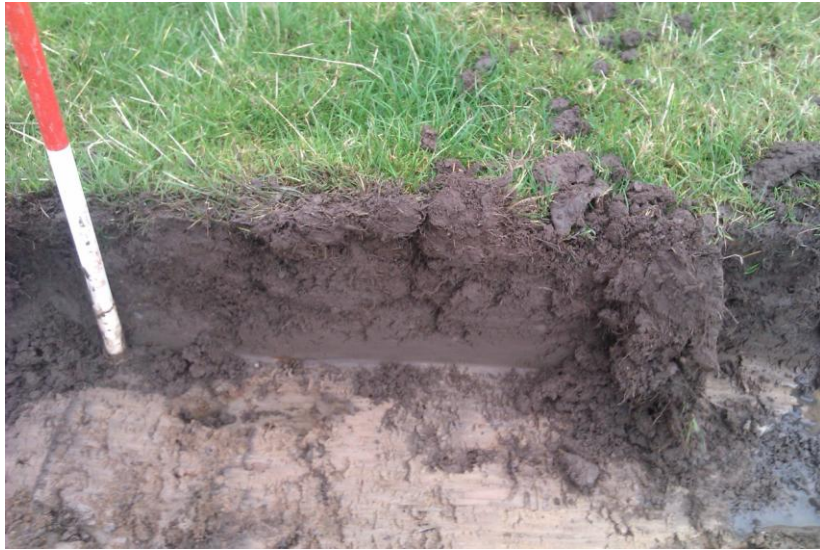
Plate 17: North-facing section of Trench 6, looking south

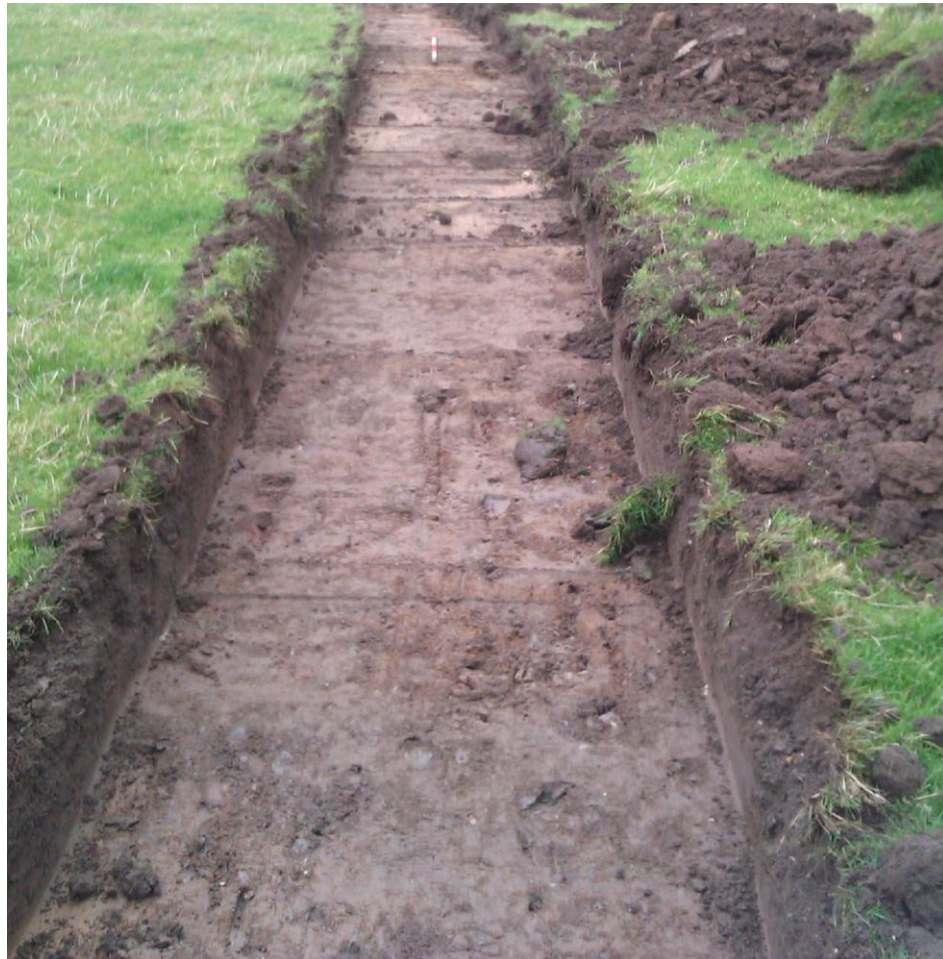
Trench 7 was located 10.0m to the north of Trench 6 and ran parallel to it. The trench was 1.3m wide and 20.0m long (Plates 18 and 19). The sod and topsoil layer in Trench 7 (C701) consisted of dark brown humic loamy clay up to 0.15m thick. Below this was a cultivation soil (C702) consisting of dark greyish brown loamy clay which contained 19th century pottery and animal bone. The cultivation soil was 0.15m thick. The subsoil in Trench 7 (C703) consisted of orange boulder clay, the surface of which was encountered at a depth of 0.30m. There were no finds or features of archaeological interest in Trench 7.

Plate 18: Trench 7 following removal of upper deposits, looking east

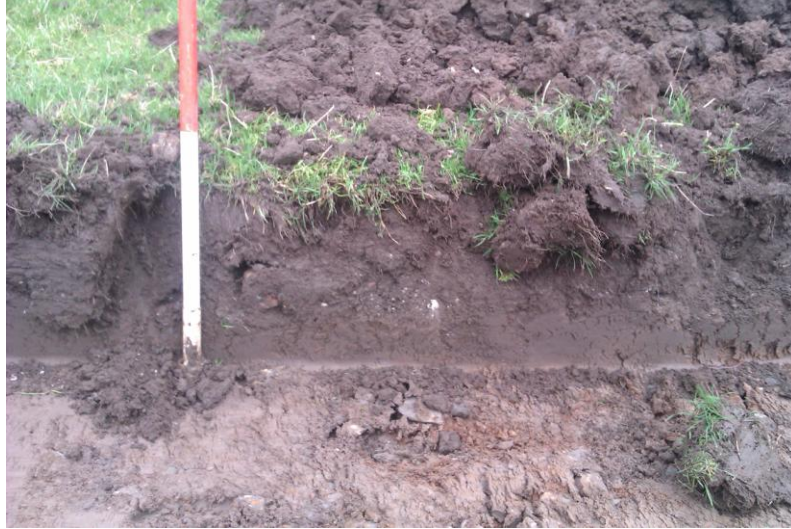
Plate 19: North-facing section of Trench 7, looking south

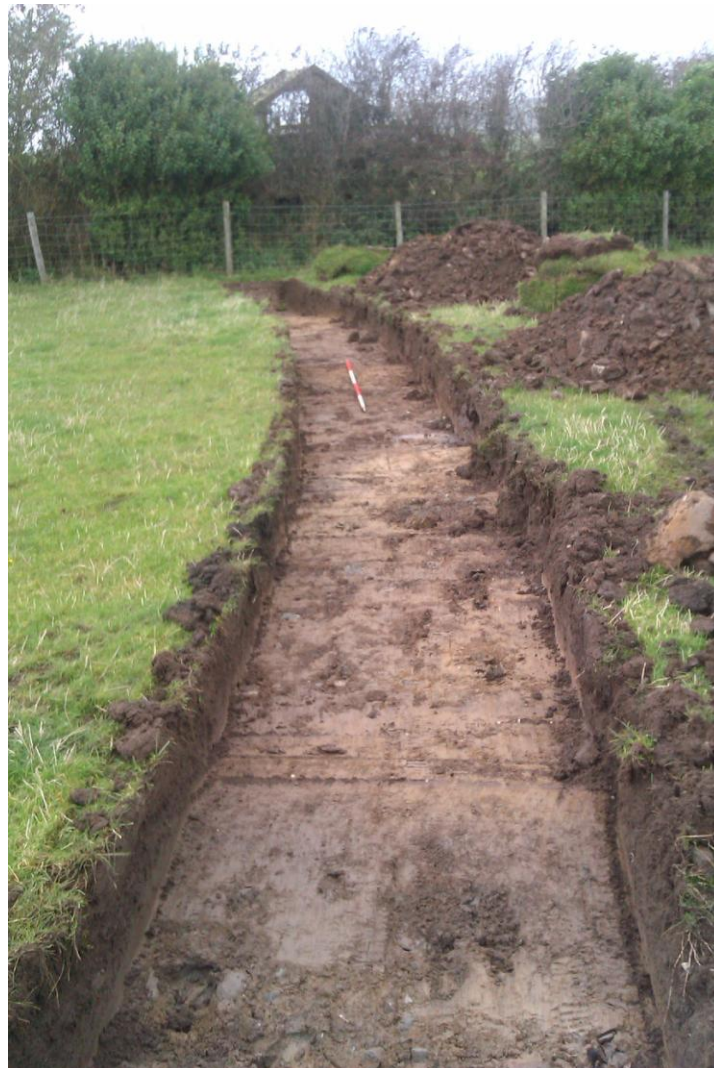
Trench 8 was located 8.0m to the north of Trench 7 and ran parallel to it. The trench was 1.4m wide and 15.0m long (Plates 20 and 21). The uppermost layer in Trench 8 was the sod and topsoil layer (C801) which consisted of greyish brown humic loamy clay with a spongy consistence. The layer was 0.15m thick. Below the sod and topsoil layer was a cultivation layer (C802) consisting of greyish brown loamy clay up to 0.20m thick. The cultivation layer contained sub-rounded and sub-angular stones around 40mm long. Below the cultivation layer was the subsoil (C803) which in Trench 8 consisted of orange boulder clay with decayed stones. Trench 8 contained no finds or features of archaeological significance.

Plate 20: Trench 8 following removal of upper deposits, looking east

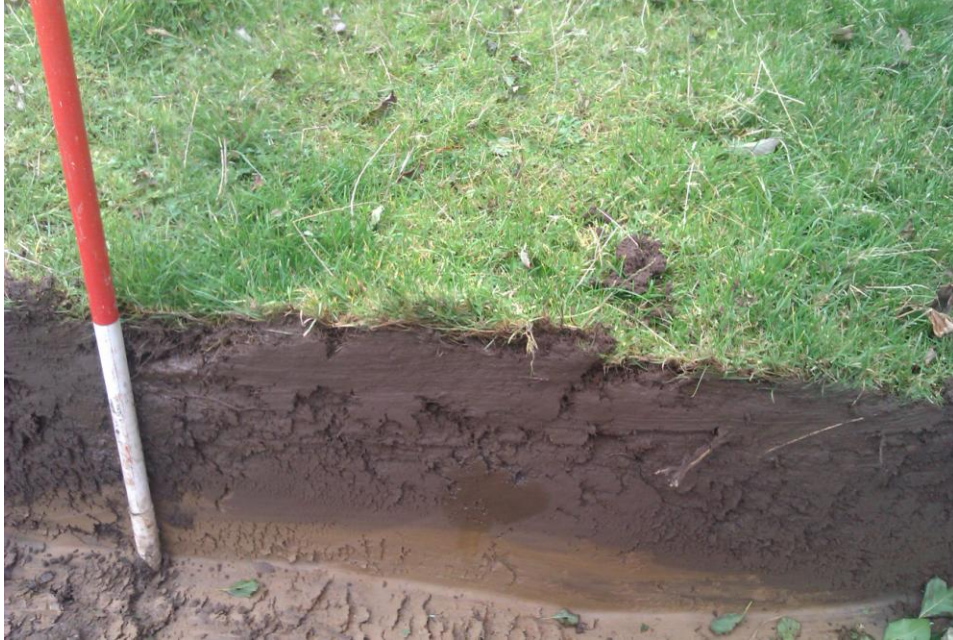
Plate 21: South-facing section of Trench 8, looking north
