Survey Report: No. 4

Survey of St Mary's Church, Ballaghanery Upper, County Down UAS/06/04

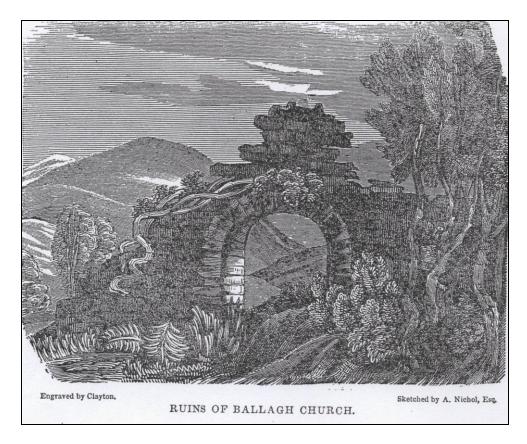
Figure 4: 1830s engraving of the chancel arch, Dublin Penny Journal

The ruins of St Mary's church have attracted the attention of artists, antiquarians and archaeologists for many years and some images confirm the steady deterioration of the structure, even over the last two centuries. For example, in an engraving from the 1830s, the east-facing elevation of the chancel arch is shown to be reasonably well-supported by masonry, although heavily overgrown (see Figure 4 below).

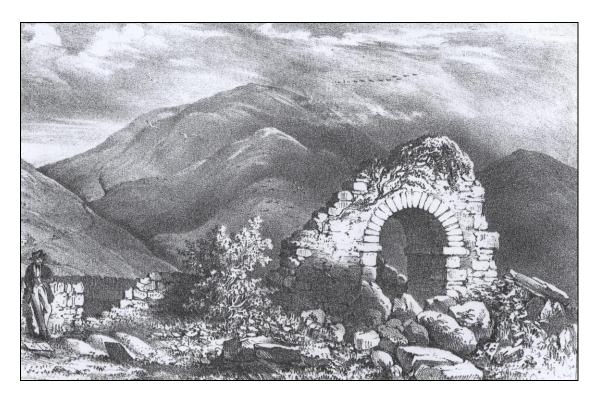
Figure 5: Sketch of the chancel arch, 1844, Archdeacon of Down

In 1844, a sketch by the Archdeacon of Down again depicted the east-facing elevation of the arch, which appeared to confirm that the arch had not deteriorated significantly (see figure 5 below). The site was described as consisting of 'the traces of a building, divided into two parts by the Arch already mentioned; namely, into a Nave 33 feet long and 18 feet wide, and a Chancel 18 feet long and 12 wide' (Archdeacon of Down 1845, 18). In 1878, Reeves referred to the site and how 'St Mary's, or Lower Mourne, was incorporated in the parish of Mourne, or Kilkeel, up to the year 1768', providing similar measurements for the nave at 33ft by 18 ft and chancel at 18 ft by 12 ft., giving an overall length of 51 feet (1878, 29). However, Reeves's reference to the church still being included in the Parish of Mourne in 1768 seems problematic, as a 1743 map shows St Mary's as an 'Old Church', suggesting that it was already a ruin at this time (Harris 1743).

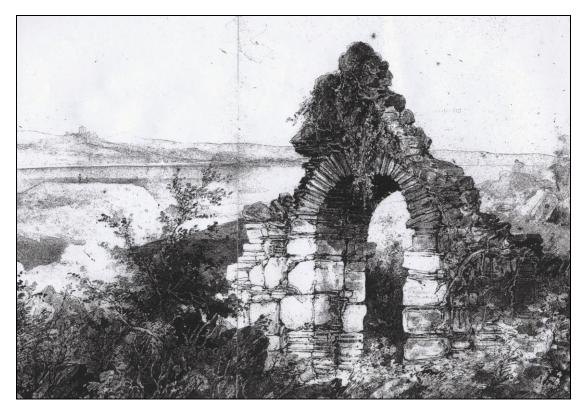
Figure 6: Mid-nineteenth century ink sketch of the chancel arch, in private ownership

An ink sketch of the west-facing elevation, dated to the mid-nineteenth century, appears to show that some of the supporting masonry around the arch has collapsed (see Figure 6 below).

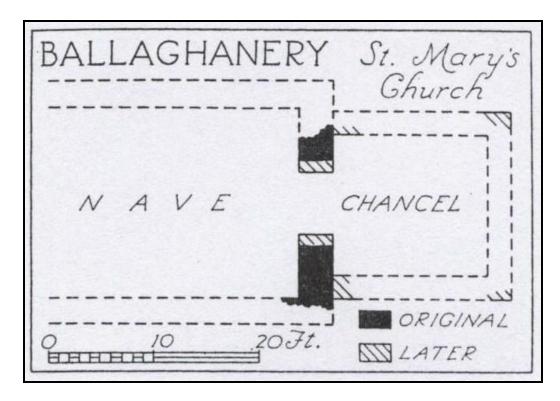
Figure 8: Plan of St Mary's Church, ASNI 1966, 298.

A description of St Mary's was included in the 1966 survey, where the size of the nave was recorded as being 'internally about 18 ft. [5.5m] by at least 33 ft.[10.1m]' and chancel as '13ft. [4.0m] by about 14 ft. 6 in. [4.4m]'. The only part of the structure described in any detail was the chancel arch as '5 ft. 10 in. [1.8m] wide, with semicircular head, consisting of undressed granite and split-stone voussoirs, rising from plain rough-dressed granite imposts to a height of 3 ft. 1 in. [1.0m] above the springing' (ASNI 1966, 298). However, the plan provided (see Figure 8 below), indicates that the remaining part of the nave was 27 feet 6 inches [8.5m] in length, suggesting that approximately 3 feet 6 inches [1.1m] had been lost as a result of the nineteenth-century widening of the adjacent roadway. If the measurements for the length of St Mary's at 51 feet [15.7m], recorded by Reeves and the Archdeacon of Down, are accepted, then the structure is much smaller than the average length for thirteenth century (63 feet 5 inches [19.5m]) and fifteenth century (60 feet 4 inches [18.6m]) churches as detailed in Figure 7 above.

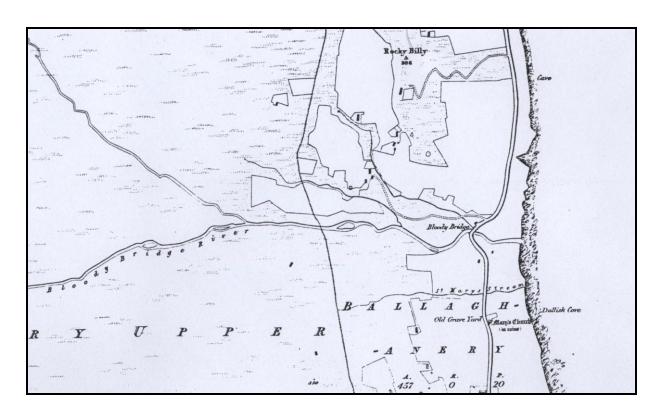
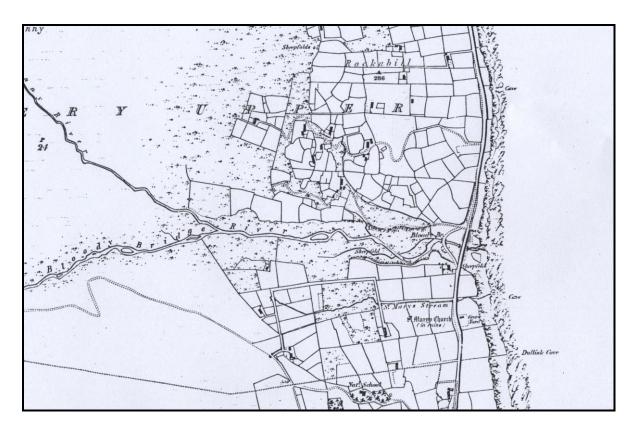
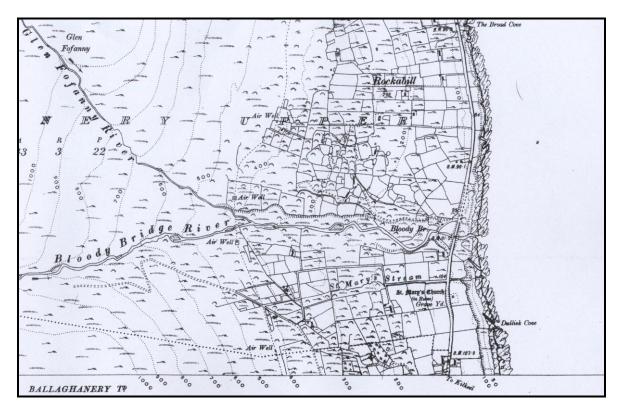
The site features on several Ordnance Survey maps (see Figures 9, 10 & 11 below). The first cartographic reference was made on the 1834 First Edition map, where a rectangular area was described as an 'Old Graveyard' including 'St Mary's Church (in ruins)'. The old medieval road and bridge are also clearly shown, as is the nearby St Mary's Stream, just to the north of the site. The site also features on the 1859 Second Edition map, when a larger and more square-shaped graveyard was shown, with a small rectangular building indicating the church remains. The new bridge across the Bloody Bridge River is also shown, as is the widened roadway to the west of the church building. The site of the graveyard was recorded again on the 1904 map, similar in size and annotation to the 1859 map.

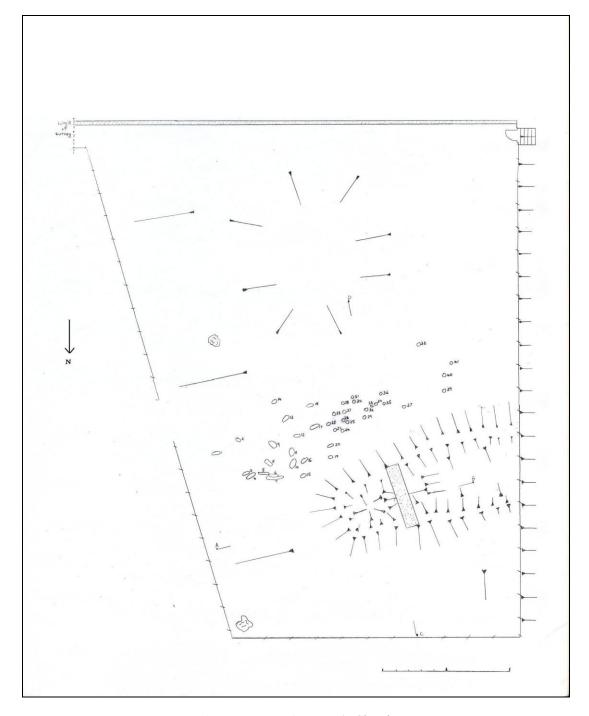
Figure 12: Plan of St Mary's Church

Plan and profile drawings were completed, using data obtained from a field survey. Measurements were obtained by using the society's *Leica Sprinter 100* electronic measuring device. Sketch plans at 1:200 scale were completed on site by recording these measurements on drafting film secured to a plane table and backing up the data on a field notebook for subsequent reference. Field plans were later transferred to a computer-based format for printing.

An almost circular depression, measuring 13.5m east-west by 12.5m north-south was noted 17m south of the church. This could either have been a feature such as a holy well (no bibliographical reference for this) or modern disturbance possibly associated with the re-construction of the nearby road.

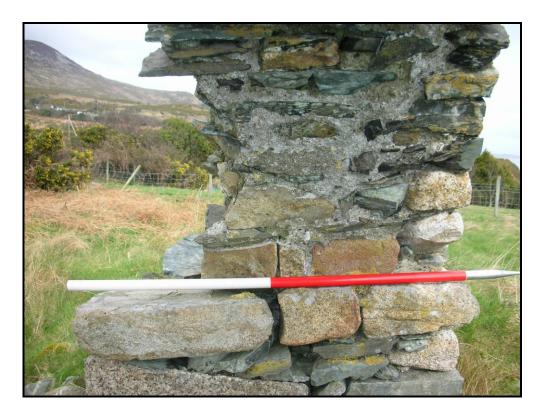
The present state of repair of the remaining structure is poor and during the 2006 UAS survey, it was observed that the chancel arch is now almost totally unsupported and in danger of complete collapse (see Figure 23 below). It is recommended that the remains of the chancel arch are protected from further erosion and perhaps consolidated by the rebuilding of part of the adjacent chancel walls.

Figure 23: Loss of supporting stonework from the chancel arch, looking north
